TEST REPORT

Ceram Reference: 116177 (QT-17994/1/ET) / Ref.1B

Project Title: Performance Testing of a Guttering System

Client: Guttermaster Ltd
Shawclough Trading Estate
Shawclough Road
Rochdale
OL12 6ND

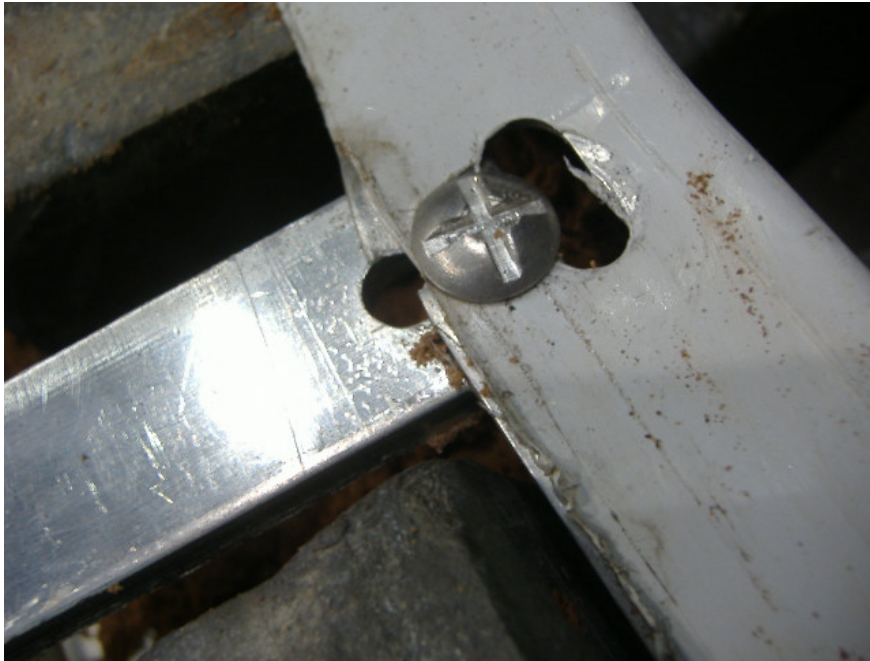
For the static maximum load test, the Gutter system was 'dead loaded' to 891kg to failure. Failure was a simultaneous splitting of the gutter front top edge connection to the supporting bracket and bending of the supporting brackets.

Plate 1 - Failure of Gutter at Bracket Connection

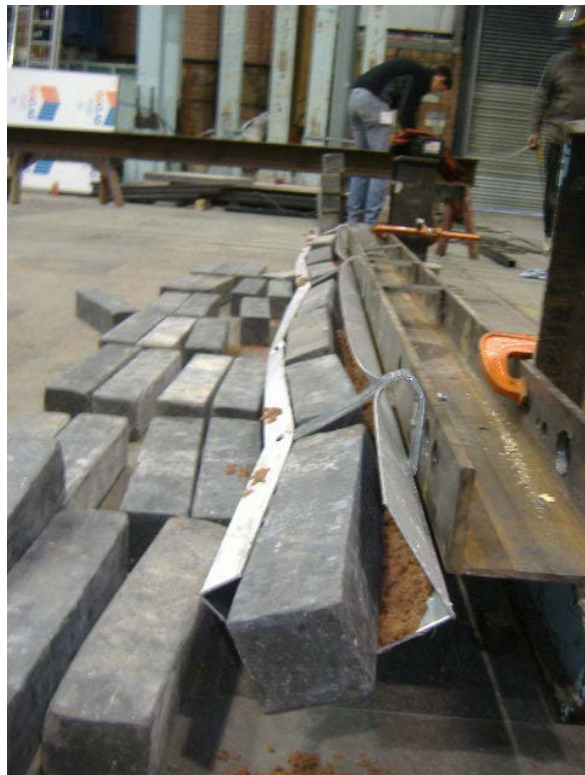
Plate 2 - Showing Bending of Brackets at Failure
