TEST REPORT

Ceram Reference: 116177 (QT-17994/1/ET) / Ref.1B

Project Title: Performance Testing of a Guttering System

Client: Guttermaster Ltd
Shawclough Trading Estate
Shawclough Road
Rochdale
OL12 6ND

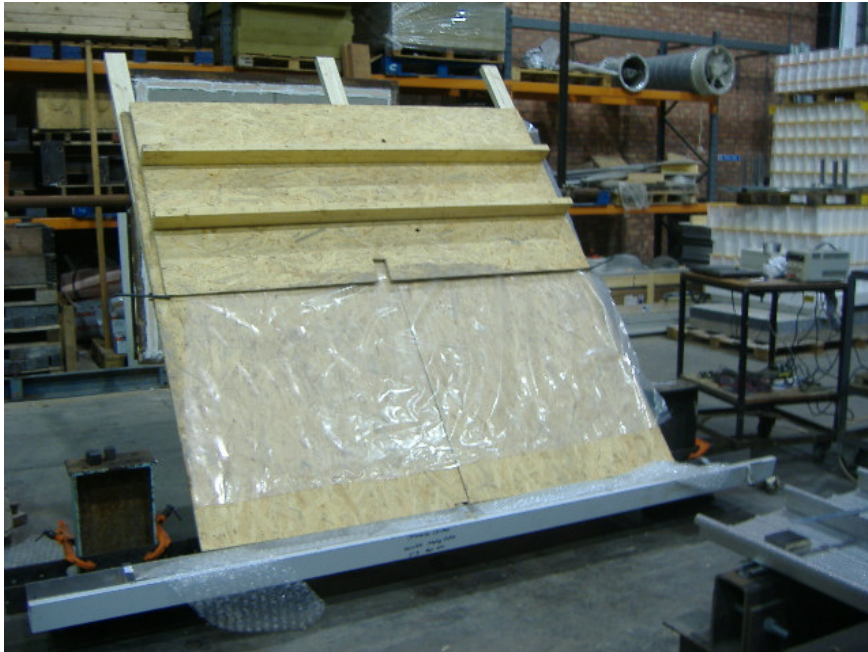
Plate 3 - Impact Test Set-up

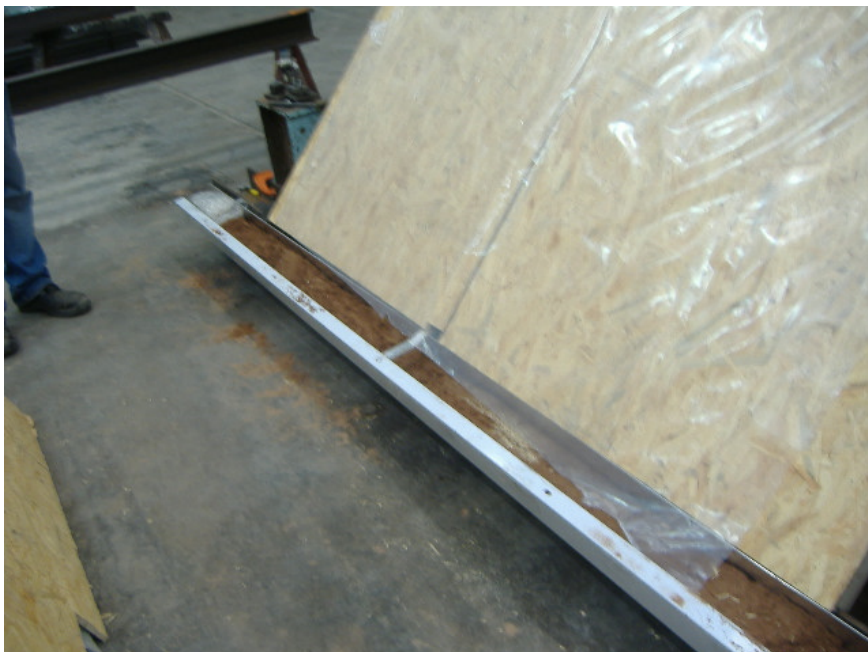
For the impact load tests, both tests (on empty gutter and half filled gutter respectively), were terminated at an applied energy of 211.5Nm at which time the test become difficult to complete. At the test termination of both respective tests, similar failure patterns were observed at the same corresponding loads for both the empty and half filled bracket tests where the brackets were severely deformed and the gutter could no longer be described as a serviceable gutter system.

Plate 4 - Impact Test Set-up Showing Gutter Half Filled with Sand
